**Flood Control Project Maintenance  
Levee Inspections**

**Fall 2018 Levee Maintenance Deficiency Summary Report**

**Flood Control Project Maintenance  
Levee Inspections****LMA District Cover Sheet****Fall 2018 Levee Inspection Results****Sutter Maintenance Yard East-West Interceptor**

**Sutter Maintenance Yard East-West Interceptor**

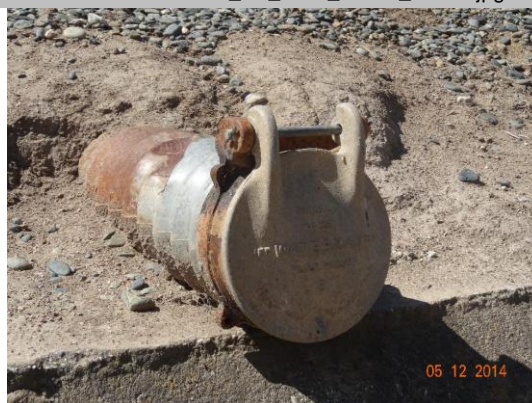
Photo 2 of 2 : UCIP\_FA\_2018\_51525\_64400.jpg

Comment Code						
Inspector Comment						
FS_ID:51525 DS_ID:20115 EP_NO: N/A Repair Type: Non-Urgent Crossing Status: Found UCIP Comments: 4/10/217 Overgrown vegetation was blocking access to this pipe. It was not inspected. (DWR Sutter Yard-AFreitag)10/11/2016 Crossing appears to be in good condition.(DWR Sutter Yard - afreitag)4/19/2016 Crossing appears to be in good condition.5/12/2015 Crossing appears in good condition. No noticeable issues to report.11/17/2014 Same as last inspection.5/12/2014 New flapgate installed on WS pipe end.11/4/2013 Same as last inspection.5/15/2013 Same as last inspection.10/16/2012 Pipe not permitted and has no flap gate. FIELD_STRUCT_DESC: 8-inch corrugated metal drainage pipe through the levee, 1.5 feet below the crown. Outlet visible on the waterside (WS). Unable to locate the inlet on the landside (LS). No permit has been identified since crossing was field discovered in 2012. FS Date: 4/12/2017 10:57:08 AM

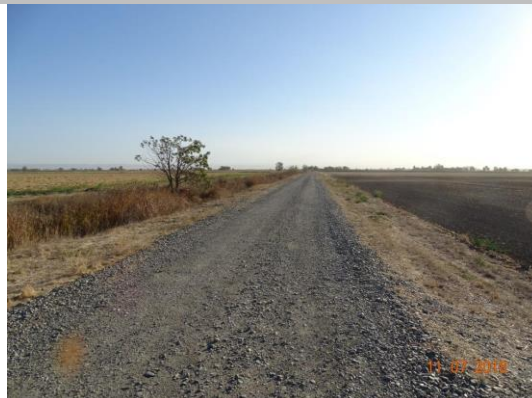
Photo 1 of 1 : FA\_2018\_ST0020\_213\_8\_20181113\_00023.jpg

LM Start	1.36	Rating **	A	Issue No.	8
LM End	1.60	Issue Type +	Ma	Location *	LS
Category	Earthen Levee			GPS Latitude/Longitude	
				Start	End
Item	Vegetation			39.171188°	39.171110°
				-121.734652°	-121.730225°
DWR ID	DWR_ST0020_01_f_2017_8				
Comment Code					
V1 : Control annual grass and weeds on the levee slopes and easements.					
Inspector Comment					
The vegetation was mowed along both slopes.

View of no vegetation along both slopes.

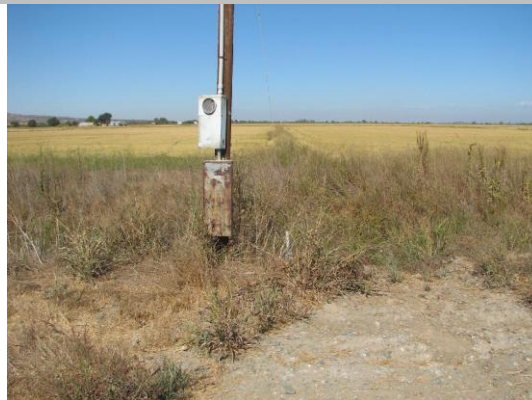
Photo 2 of 3 : UCIP\_FA\_2018\_51534\_11390.jpg

Comment Code						
Inspector Comment						
FS_ID:51534 DS_ID:19426 EP_NO: N/A Repair Type: Non-Urgent Crossing Status: Found UCIP Comments: 4/10/2017 Abandoned. (DWR Sutter Yard-AFreitag)10/11/2016 Abandoned crossing.(DWR Sutter Yard - aFreitag)4/19/2016 Abandoned crossing.5/12/2015 Abandoned crossing. Needs to be properly abandoned.11/17/2014 Same as last inspection.5/12/2014 Same as last inspection.11/4/2013 Same as last inspection.5/15/2013 Same as last inspection.10/16/2012 Pumping plant abandoned. Pipe abandoned and only visible at bottom of concrete standpipe. Pipe needs to be abandoned properly. FIELD_STRUCT_DESC: 12-inch galvanized iron irrigation pipe through the levee, 6 feet below the crown. 10 horsepower (HP) pump in the canal, and power pole located on the waterside (WS). 36-inch concrete standpipe located on the landside (LS) shoulder. [Additional Reference(s): DWR Levee Log, 1990. USACE Sacramento O&M Manual 135, May 1953, (HLM 0.74), Page 11, Location Section 19, As-Built Drawing No. 50-10-2816]. FS Date: 4/12/2017 12:04:36 PM

Powerpole on WS shoulder.

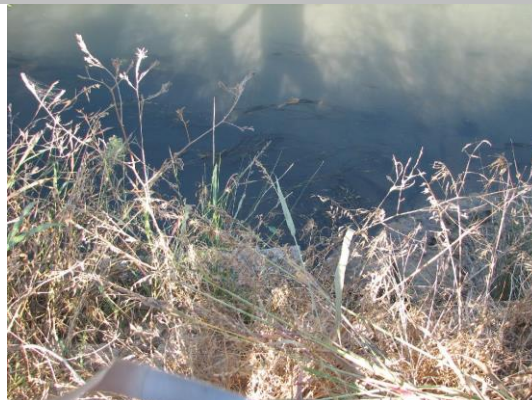
Photo 3 of 3 : UCIP\_FA\_2018\_51534\_11389.jpg

Concrete base along WS toe.

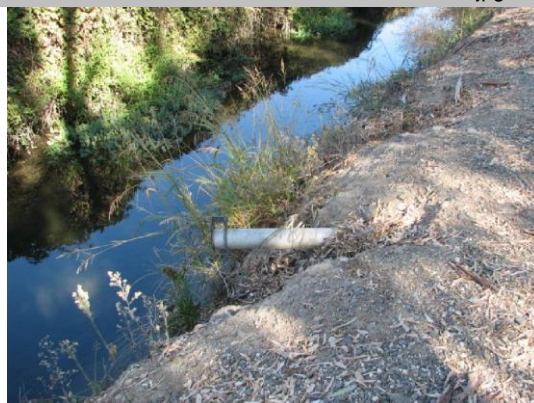
Photo 1 of 2 : UCIP\_FA\_2018\_51541\_14335.jpg

Comment Code						
Inspector Comment						
FS_ID:51541 DS_ID:20119 EP_NO: N/A Repair Type: Non-Urgent Crossing Status: Found UCIP Comments: 4/10/2017 Crossing appears to be in good condition. (DWR Sutter Yard- AFreitag)10/11/2016 Crossing appears to be in good condition.(DWR Sutter Yard - afreitag)4/19/2016 Crossing appears to be in good condition.5/12/2015 Crossing appears in good condition. No noticeable issues to report.11/17/2014 Same as last inspection.5/12/2014 Same as last inspection.11/4/2013 Same as last inspection.5/15/2013 Same as last inspection.10/16/2012 No permit identified for crossing. FIELD_STRUCT_DESC: 5-inch aluminum drainage pipe through the levee, 1 foot below the crown. Flap gate located on the waterside (WS) with concrete headwall block on the landside (LS). No permit has been identified since crossing was field discovered in 2012. FS Date: 4/12/2017 12:28:21 PM

pipe with flap gate on WS shoulder.

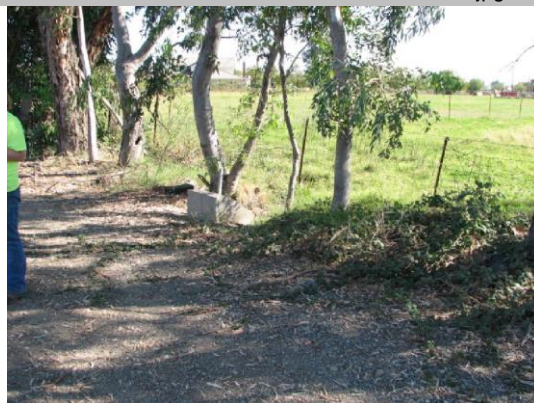
Photo 2 of 2 : UCIP\_FA\_2018\_51541\_14334.jpg

Concrete headwall on LS shoulder.

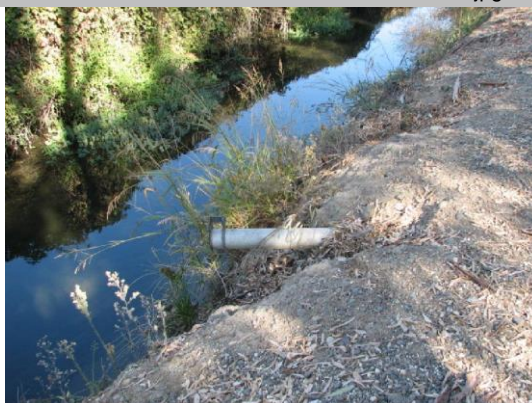
Photo 1 of 1 : UCIP\_FA\_2018\_51542\_14341.jpg

Comment Code						
Inspector Comment						
FS_ID:51542 DS_ID:20122 EP_NO: N/A Repair Type: Non-Urgent Crossing Status: Found UCIP Comments: 4/10/2017 Crossing appears to be in good condition. (DWR Sutter Yard- AFreitag)10/11/2016 Crossing appears to be in good condition.(DWR Sutter Yard - afreitag)4/19/2016 Crossing appears to be in good condition.5/12/2015 Crossing appears in good condition. No noticeable issues to report.11/17/2014 Same as last inspection.5/12/2014 Same as last inspection.11/4/2013 Same as last inspection.5/15/2013 Same as last inspection.10/16/2012 No permit identified for crossing. FIELD_STRUCT_DESC: 7-inch flexible high-density polyethylene (HDPE) drainage pipe through the levee, 1 foot below the crown. No permit has been identified since crossing was field discovered in 2012. FS Date: 4/12/2017 12:29:06 PM

HDPE pipe on upstream side of aluminum pipe shown in picture.

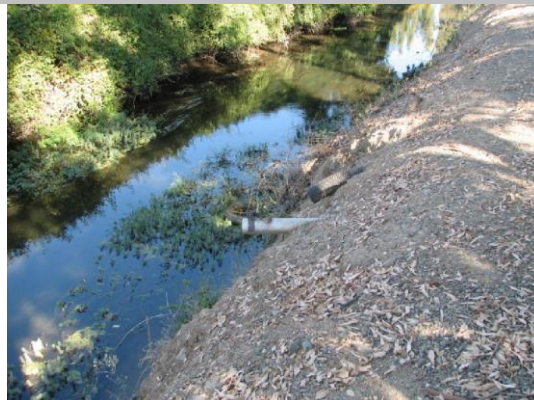
Photo 1 of 2 : UCIP\_FA\_2018\_51543\_14339.jpg

Comment Code					
Inspector Comment					
FS_ID:51543 DS_ID:20120 EP_NO: N/A Repair Type: Non-Urgent Crossing Status: Found UCIP Comments: 4/10/2017 Crossing appears to be in good condition. (DWR Sutter Yard- AFreitag)10/11/2016 Crossing appears to be in good condition. (DWR Sutter Yard - afreitag)4/19/2016 Crossing appears to be in good condition.5/12/2015 Crossing appears in good condition. No noticeable issues to report.11/17/2014 Same as last inspection.5/12/2014 Same as last inspection.11/4/2013 Same as last inspection.5/15/2013 Same as last inspection.10/16/2012 No permit identified for crossing. FIELD_STRUCT_DESC: 5-inch aluminum drainage pipe through the levee, 1 foot below the crown. Flap gate located on the waterside (WS) with concrete headwall block on the landside (LS). No permit has been identified since crossing was field discovered in 2012. FS Date: 4/12/2017 12:30:05 PM

Pipe and flap gate on WS shoulder.

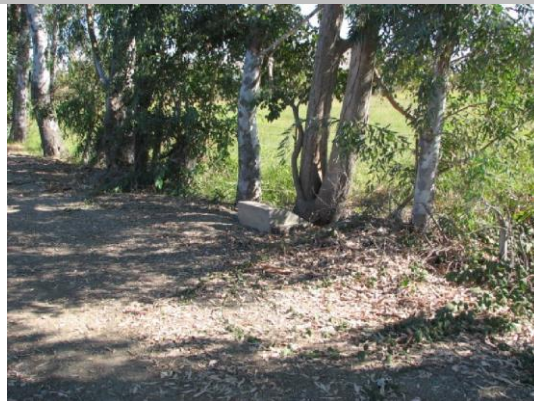
Photo 2 of 2 : UCIP\_FA\_2018\_51543\_14338.jpg

Concrete headwall on LS shoulder.

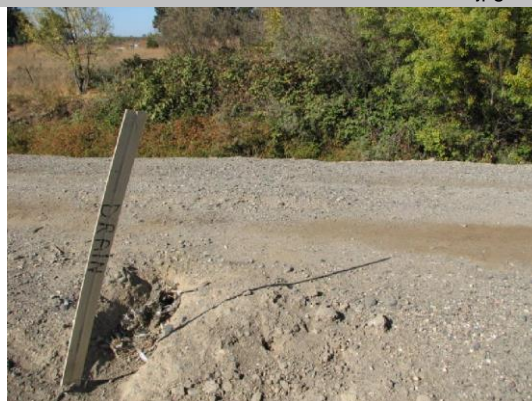
Photo 1 of 3 : UCIP\_FA\_2018\_51546\_21743.jpg

Comment Code					
Inspector Comment					
FS_ID:51546 DS_ID:20123 EP_NO: N/A Repair Type: Non-Urgent Crossing Status: Found UCIP Comments: 4/10/2017 Crossing appears to be in good condition. (DWR Sutter Yard- AFreitag)10/11/2016 Crossing appears to be in good condition.(DWR Sutter Yard - afreitag)4/19/2016 Crossing appears to be in good condition.5/12/2015 Crossing appears in good condition. No noticeable issues to report.11/17/2014 Same as last inspection.5/12/2014 Same as last inspection.5/22/2013 Erosion under pipe outlet has been repaired. Bank lined with rock to prevent future erosion.5/15/2013 Flexible pipe has been replaced with 6.5 inch steel with flap gate on WS. Erosion under WS outlet.11/4/2013 Same as last inspection.10/16/2012 No permit identified for crossing. FIELD_STRUCT_DESC: 7-inch flexible high-density polyethylene (HDPE) drainage pipe through the levee, 1 foot below the crown. Signage for crossing is visible on the landside (LS) shoulder. Outlet visible on the waterside (WS) shoulder. No permit has been identified since crossing was field discovered in 2012. FS Date: 4/12/2017 12:32:05 PM

Inlet and signage for crossing on LS shoulder.

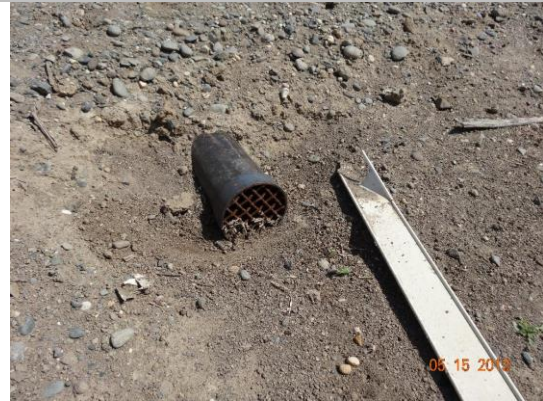
Photo 3 of 3 : UCIP\_FA\_2018\_51546\_21744.jpg

Comment Code						
Inspector Comment						
FS_ID:51546 DS_ID:20123 EP_NO: N/A Repair Type: Non-Urgent Crossing Status: Found UCIP Comments: 4/10/2017 Crossing appears to be in good condition. (DWR Sutter Yard- AFreitag)10/11/2016 Crossing appears to be in good condition.(DWR Sutter Yard - afreitag)4/19/2016 Crossing appears to be in good condition.5/12/2015 Crossing appears in good condition. No noticeable issues to report.11/17/2014 Same as last inspection.5/12/2014 Same as last inspection.5/22/2013 Erosion under pipe outlet has been repaired. Bank lined with rock to prevent future erosion.5/15/2013 Flexible pipe has been replaced with 6.5 inch steel with flap gate on WS. Erosion under WS outlet.11/4/2013 Same as last inspection.10/16/2012 No permit identified for crossing. FIELD_STRUCT_DESC: 7-inch flexible high-density polyethylene (HDPE) drainage pipe through the levee, 1 foot below the crown. Signage for crossing is visible on the landside (LS) shoulder. Outlet visible on the waterside (WS) shoulder. No permit has been identified since crossing was field discovered in 2012. FS Date: 4/12/2017 12:32:05 PM

Pipe end with grate on LS.

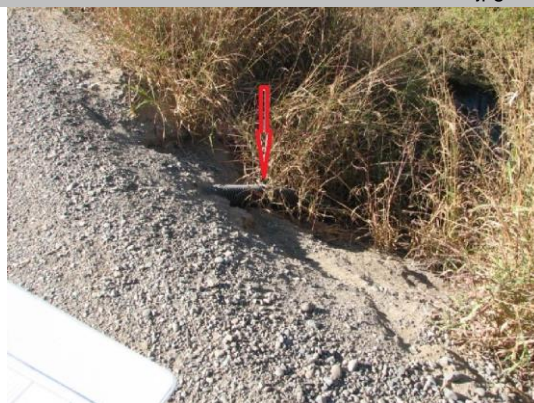
Photo 1 of 3 : UCIP\_FA\_2018\_51547\_21749.jpg

Comment Code						
Inspector Comment						
FS_ID:51547 DS_ID:20124 EP_NO: N/A Repair Type: Non-Urgent Crossing Status: Found UCIP Comments: 4/10/2017 Crossing appears to be in good condition. (DWR Sutter Yard- AFreitag)10/11/2016 Crossing appears to be in good condition.(DWR Sutter Yard - afreitag)4/19/2016 Crossing appears to be in good condition.5/12/2015 Crossing appears in good condition. No noticeable issues to report.11/17/2014 Same as last inspection.5/12/2014 Same as last inspection.11/4/2013 Same as last inspection.5/22/2013 Erosion under pipe outlet has been repaired and bank lined with rock to prevent future erosion.5/15/2013 Flexible pipe has been replaced with 6.5 inch steel with flap gate on WS outlet. Erosion under WS outlet.10/16/2012 No permit identified for this crossing. FIELD_STRUCT_DESC: 7-inch flexible high-density polyethylene (HDPE) drainage pipe through the levee, 1 foot below the crown. Pipe visible on the waterside (WS) shoulder. Intake with grate visible on the landside (LS). No permit has been identified since crossing was field discovered in 2012. FS Date: 4/12/2017 12:32:52 PM

Pipe on WS shoulder.

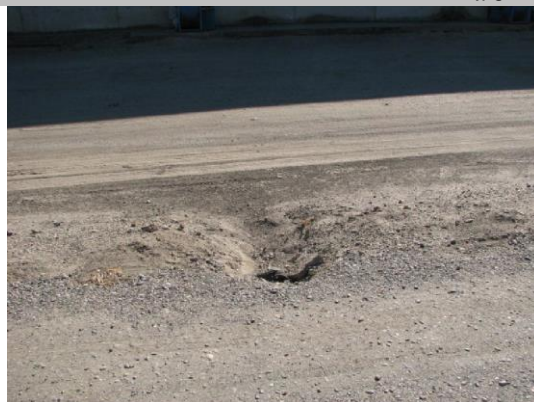
Photo 2 of 3 : UCIP\_FA\_2018\_51547\_21748.jpg

Pipe on LS shoulder.

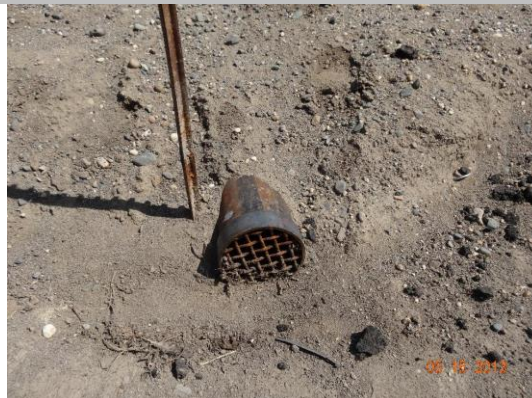
Photo 3 of 3 : UCIP\_FA\_2018\_51547\_21750.jpg

Comment Code						
Inspector Comment						
FS_ID:51547 DS_ID:20124 EP_NO: N/A Repair Type: Non-Urgent Crossing Status: Found UCIP Comments: 4/10/2017 Crossing appears to be in good condition. (DWR Sutter Yard- AFreitag)10/11/2016 Crossing appears to be in good condition.(DWR Sutter Yard - afreitag)4/19/2016 Crossing appears to be in good condition.5/12/2015 Crossing appears in good condition. No noticeable issues to report.11/17/2014 Same as last inspection.5/12/2014 Same as last inspection.11/4/2013 Same as last inspection.5/22/2013 Erosion under pipe outlet has been repaired and bank lined with rock to prevent future erosion.5/15/2013 Flexible pipe has been replaced with 6.5 inch steel with flap gate on WS outlet. Erosion under WS outlet.10/16/2012 No permit identified for this crossing. FIELD_STRUCT_DESC: 7-inch flexible high-density polyethylene (HDPE) drainage pipe through the levee, 1 foot below the crown. Pipe visible on the waterside (WS) shoulder. Intake with grate visible on the landside (LS). No permit has been identified since crossing was field discovered in 2012. FS Date: 4/12/2017 12:32:52 PM

LS intake with grate.

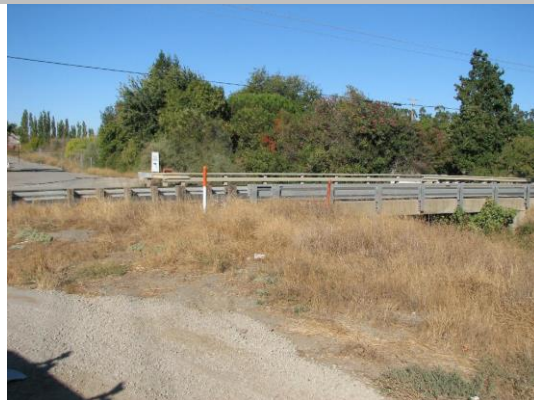
Photo 1 of 2 : UCIP\_FA\_2018\_51549\_14369.jpg

Comment Code						
Inspector Comment						
FS_ID:51549						
DS_ID:20125						
EP_NO: N/A						
Repair Type: Non-Urgent						
Crossing Status: Found						
UCIP Comments: 4/10/2017 Crossing appears to be in good condition. (DWR Sutter Yard- AFreitag)10/11/2016 Crossing appears to be in good condition.(DWR Sutter Yard - afreitag)4/19/2016 Crossing appears to be in good condition.5/12/2015 Crossing appears in good condition. No noticeable issues to report.11/17/2014 Same as last inspection.5/12/2014 Same as last inspection.11/4/2013 Same as last inspection.5/15/2013 Same as last inspection.10/16/2012 No permit identified for this crossing.						
FIELD_STRUCT_DESC: Steel fiber optics conduit of an unknown size through the levee, at an unknown depth. Crossing is located on the east side of Township Road bridge. Marker visible on east side of North Township Drive, south of interceptor. Owner is Pacific, and their contact number is 1-877-735-7366. No permit has been identified since crossing was field discovered in 2012.

Marker on east side of N Township Drive, south of interceptor.

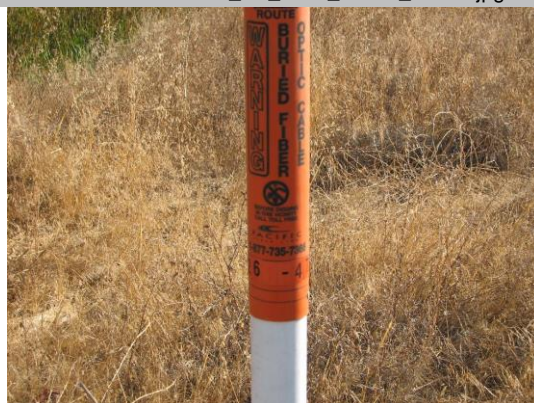
Photo 2 of 2 : UCIP\_FA\_2018\_51549\_14368.jpg

Closeup of marker.

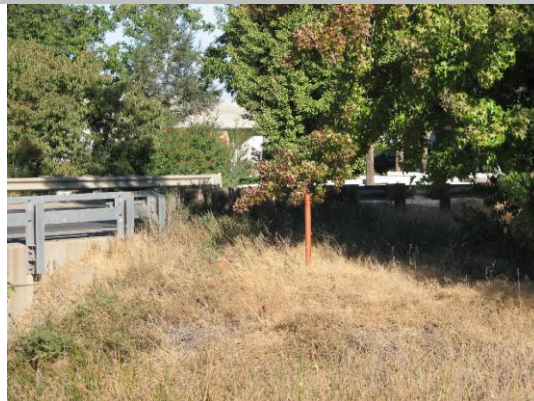
Photo 2 of 3 : UCIP\_FA\_2018\_51550\_14366.jpg

Comment Code					
Inspector Comment					
FS_ID:51550 DS_ID:20126 EP_NO: N/A Repair Type: Non-Urgent Crossing Status: Found UCIP Comments: 4/10/2017 Crossing appears to be in good condition. (DWR Sutter Yard- AFreitag)10/11/2016 Crossing appears to be in good condition.(DWR Sutter Yard - afreitag)4/19/2016 Crossing appears to be in good condition.5/12/2015 Crossing appears in good condition. No noticeable issues to report.11/17/2014 Same as last inspection.5/12/2014 Same as last inspection.11/4/2013 Same as last inspection.5/15/2013 Same as last inspection.10/16/2012 No permit identified for this crossing. FIELD_STRUCT_DESC: Steel gas line crossing of an unknown size through the levee, at an unknown depth. Sign visible on the landside (LS). No permit has been identified since crossing was field discovered in 2012. FS Date: 4/12/2017 12:35:53 PM

Gasline marker on east side of N Township Road North of interceptor

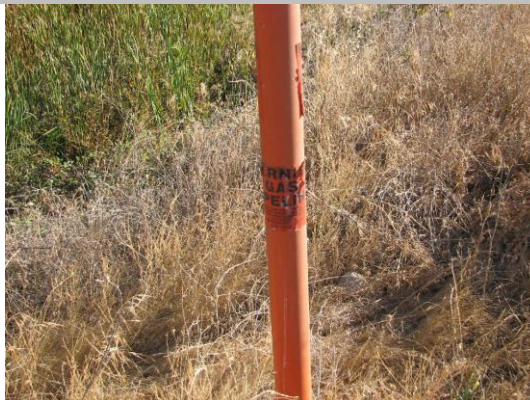
Photo 3 of 3 : UCIP\_FA\_2018\_51550\_14365.jpg

Comment Code						
Inspector Comment						
FS_ID:51550 DS_ID:20126 EP_NO: N/A Repair Type: Non-Urgent Crossing Status: Found UCIP Comments: 4/10/2017 Crossing appears to be in good condition. (DWR Sutter Yard- AFreitag)10/11/2016 Crossing appears to be in good condition.(DWR Sutter Yard - afreitag)4/19/2016 Crossing appears to be in good condition.5/12/2015 Crossing appears in good condition. No noticeable issues to report.11/17/2014 Same as last inspection.5/12/2014 Same as last inspection.11/4/2013 Same as last inspection.5/15/2013 Same as last inspection.10/16/2012 No permit identified for this crossing. FIELD_STRUCT_DESC: Steel gas line crossing of an unknown size through the levee, at an unknown depth. Sign visible on the landside (LS). No permit has been identified since crossing was field discovered in 2012. FS Date: 4/12/2017 12:35:53 PM

gasline marker.

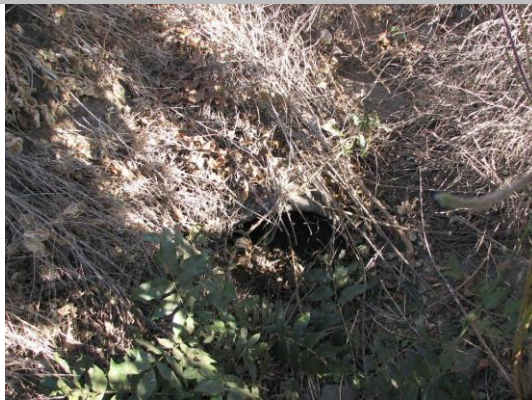
Photo 1 of 3 : UCIP\_FA\_2018\_51551\_14374.jpg

Comment Code					
Inspector Comment					
FS_ID:51551 DS_ID:20127 EP_NO: N/A Repair Type: Non-Urgent Crossing Status: Found UCIP Comments: 4/10/2017 Blackberries around the WS pipe outlet were sprayed and killed. Pipe appears to be in good condition. (DWR Sutter Yard- A Freitag)10/11/2016 WS flap gate is being overgrown by blackberries that could possibly hinder its operation. They should be sprayed and cleared back.(DWR Sutter Yard - a Freitag)4/19/2016 Crossing appears to be in good condition.5/12/2015 Crossing appears in good condition. No noticeable issues to report.11/17/2014 Same as last inspection.5/12/2014 Same as last inspection.5/15/2013 Same as last inspection.11/4/2013 Same as last inspection.10/16/2012 No permit identified for this crossing. FIELD_STRUCT_DESC: 18-inch asphalt coated corrugated metal drainage pipe through the levee, 6 feet below the crown. Flap gate is located on the waterside (WS). Pipe is visible on the landside (LS) toe. No permit has been identified since crossing was field discovered in 2012. FS Date: 4/12/2017 12:36:34 PM

Pipe on LS toe.

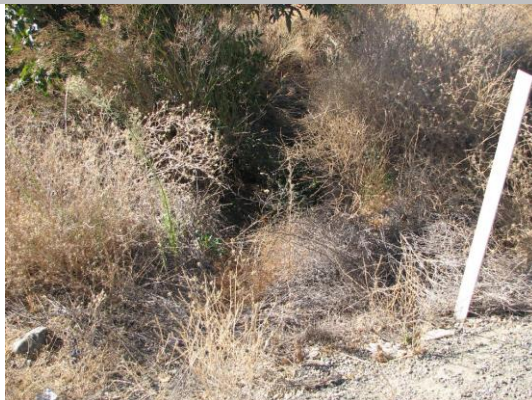
Photo 2 of 3 : UCIP\_FA\_2018\_51551\_14373.jpg

Location of pipe on LS toe.

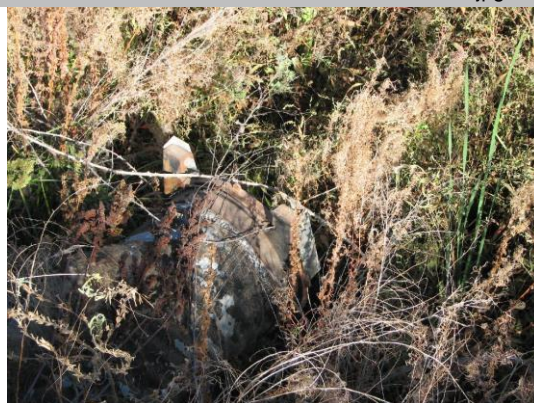
Photo 3 of 3 : UCIP\_FA\_2018\_51551\_14372.jpg

Comment Code						
Inspector Comment						
FS_ID:51551 DS_ID:20127 EP_NO: N/A Repair Type: Non-Urgent Crossing Status: Found UCIP Comments: 4/10/2017 Blackberries around the WS pipe outlet were sprayed and killed. Pipe appears to be in good condition. (DWR Sutter Yard- A Freitag)10/11/2016 WS flap gate is being overgrown by blackberries that could possibly hinder its operation. They should be sprayed and cleared back.(DWR Sutter Yard - a Freitag)4/19/2016 Crossing appears to be in good condition.5/12/2015 Crossing appears in good condition. No noticeable issues to report.11/17/2014 Same as last inspection.5/12/2014 Same as last inspection.5/15/2013 Same as last inspection.11/4/2013 Same as last inspection.10/16/2012 No permit identified for this crossing. FIELD_STRUCT_DESC: 18-inch asphalt coated corrugated metal drainage pipe through the levee, 6 feet below the crown. Flap gate is located on the waterside (WS). Pipe is visible on the landside (LS) toe. No permit has been identified since crossing was field discovered in 2012. FS Date: 4/12/2017 12:36:34 PM

Flap gate on WS slope.
